## Supporting investigations of surface defects in MR-I 7000E imprint resist on ON209 virgin wafers

**Re** Defects in MR-i7030 imprint photoresist coatings on wafers

15. december 2009  
NCR 0001 - supporting  
notes  
AJOE

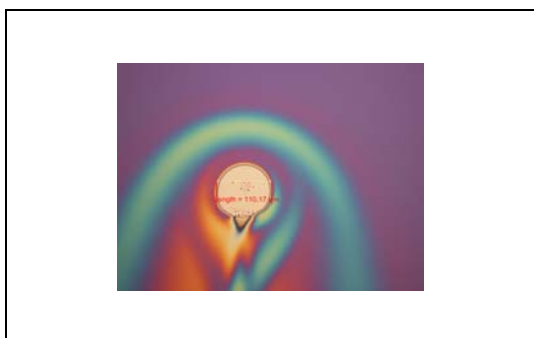
1. Round objects in the resist with what appears as a ,volcano' shape around it (Figure 1)
2. Elongated areas of what appears to be thicker resist (Figure 2 and Figure 3)

The lines extending from the structure are consistent with the spin pattern.

Figure 1. Structure on a new ON209 wafer straight from the box.

The defects seen in MRI-7030E resist on wafers were due to the condition of the photoresist itself. The problem could be solved by degassing and filtering the resist.

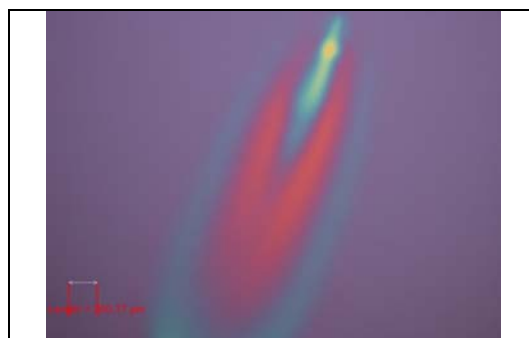
Figure 2. Structure on a new ON209 wafers straight from the box.

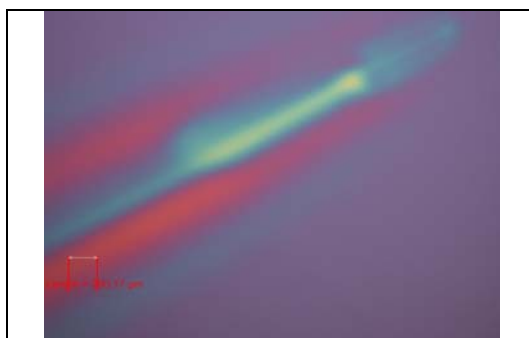
Figure 3. Structure on a new ON209 wafers straight from the box.

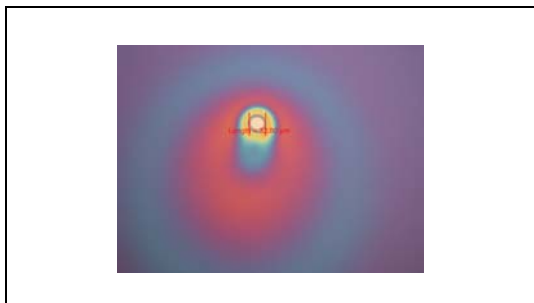
The results after pre-treatment were compared with the control group of the non-pre-treated wafers. No different appeared between the groups: the same number and the same kind of defect are detected after the spinning.

Some examples of the defects are illustrated (Figure 7 and Figure 8). All defects looked like coming from small particles or bubbles.

Figure 7. Structure on a ON209 wafer subjected to BHF dip prior to spinning.

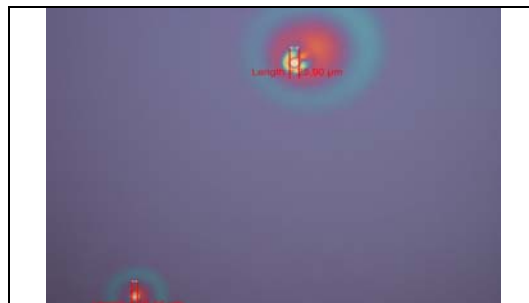
Figure 8. Structures on a ON209 wafer subjected to BHF dip prior to spinning.

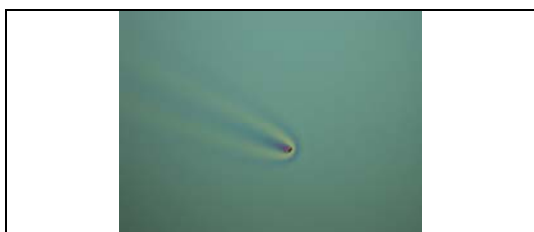
The results of the tests are shown (Figure 9 and Figure 10). Generally the coatings looked better but did have some defects at the edge of wafers similar to previously seen.

Figure 9. Structure on a pre-treated wafer, spin-coated By Microresist. Defects at the edge of sample.

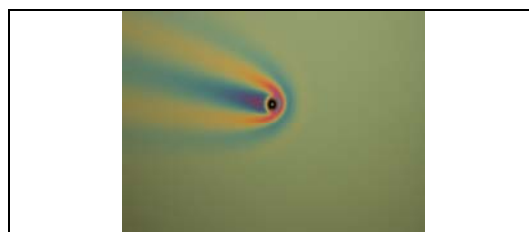
Figure 10. Structure on a pre-treated wafer, spin-coated By Microresist. Defects at the edge of sample.
