## Supporting investigations of surface defects in MR-I 7000E imprint resist on ON209 virgin wafers

**Re** Defects in MR-i7030 imprint photoresist coatings on wafers

15. december 2009  
NCR 0001 - supporting  
notes  
AJOE

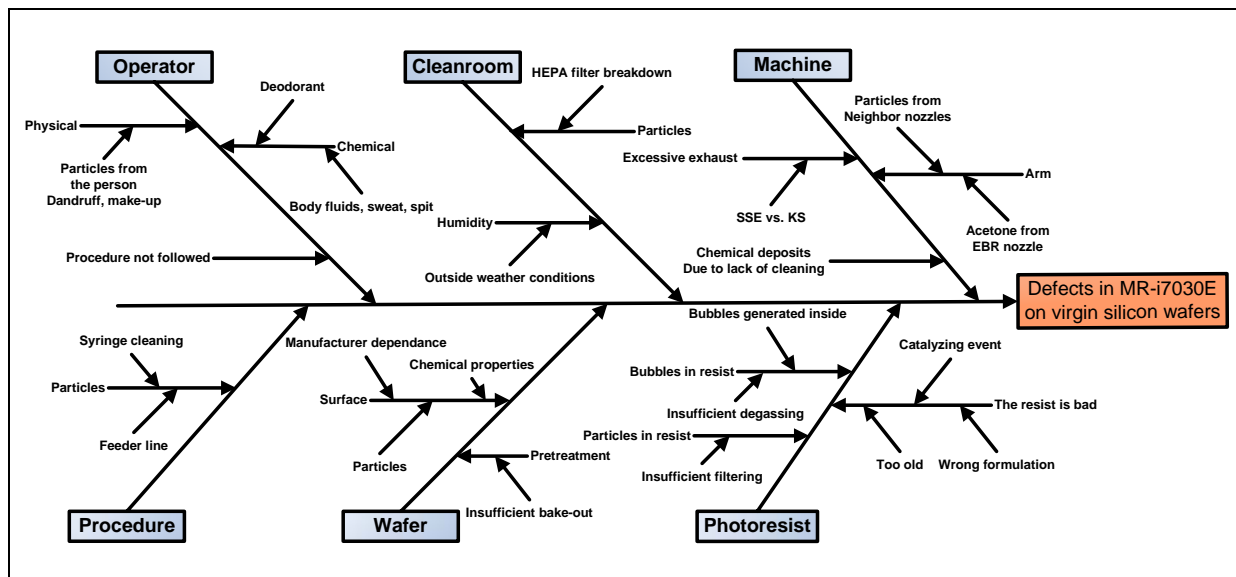
The most obvious and quite a few unlikely explanations to the defects have been collected in the fishbone diagram (Figure 4).

Figure 4. Ishikawa (fishbone) diagram for the defects on wafers.

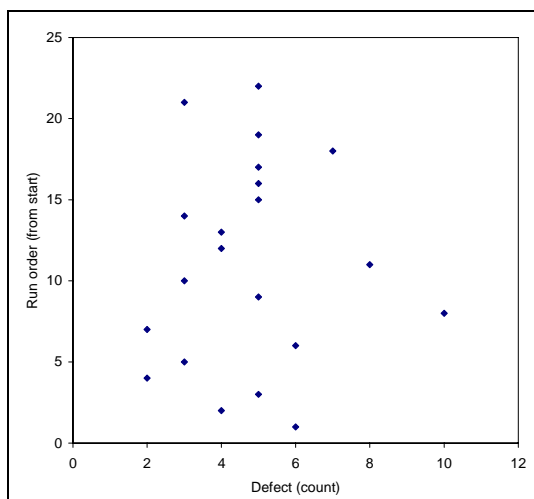
Plotting the run order and spin speed as a function of defect count (Figure 5 and Figure 6) does not reveal anything conclusive. There is a hint of higher defect count with higher speeds, but the data does not give enough statistical basis to draw solid conclusions.

Figure 5. Plot of run order vs. defect count.

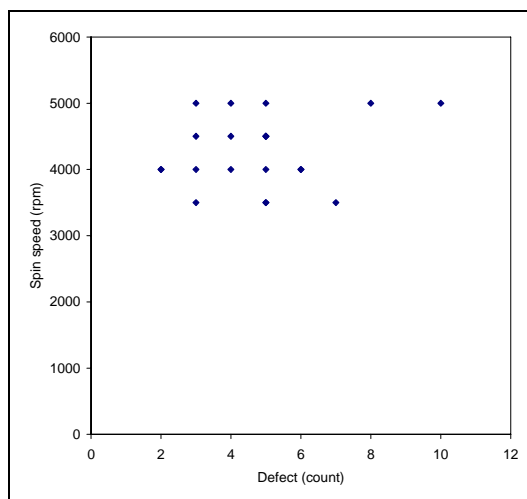
Figure 6. Plot of spin speed vs. defect count
